BELZONA[®]
GREAT LAKES

**STEEL
PROCESS TANK
LEAK REPAIR**

LEAK REPAIR
AUGUST, 2017

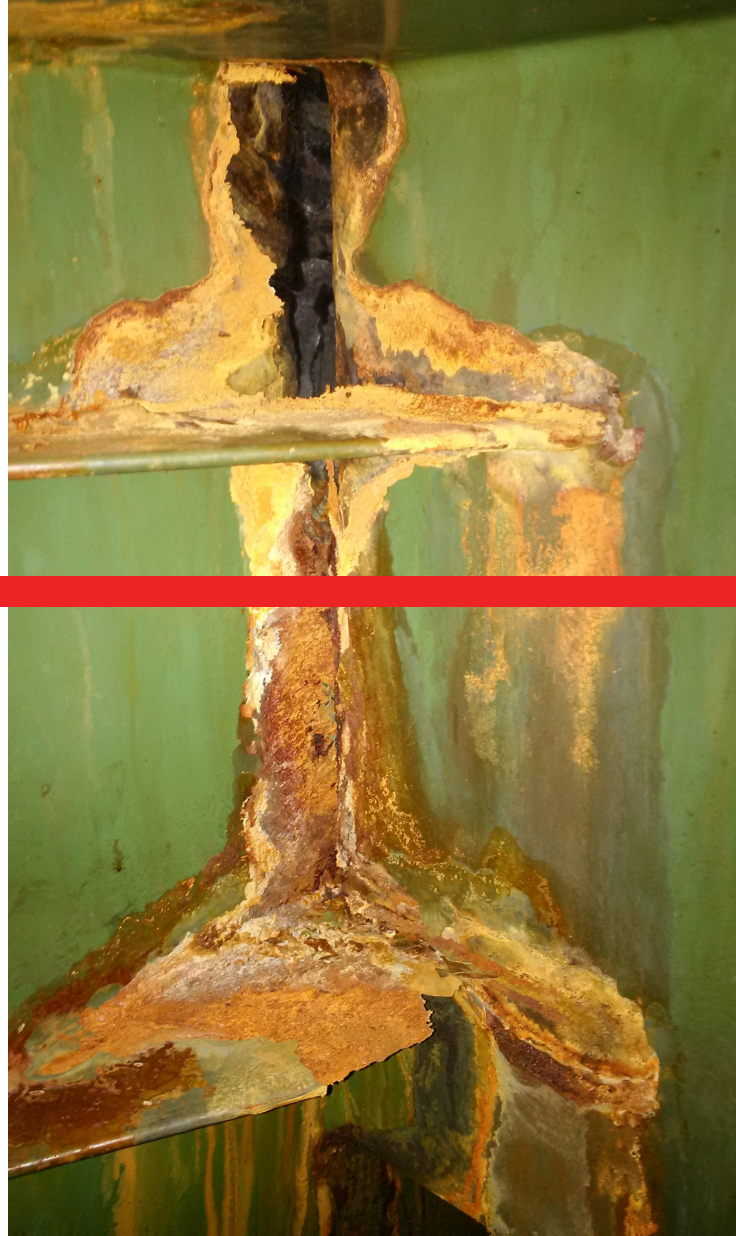
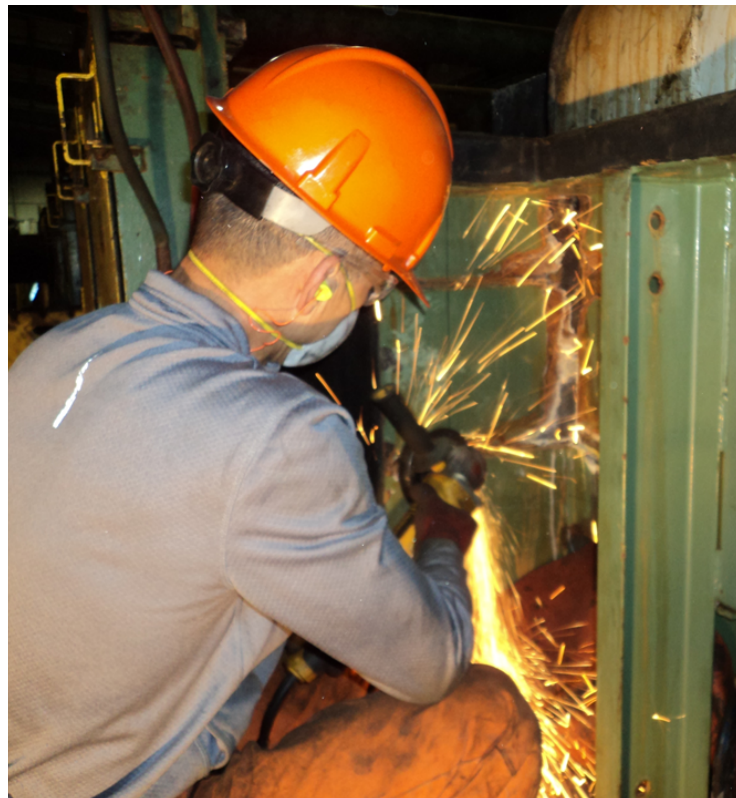
One of the major steel producer's in Canada, had a leak in one of their pickle line tanks. The tank operates at high temperatures and contains high concentrations of Hydrochloric acid (HCl). The tank had a rubber lining in place that was somewhat intact but somewhere the acid was leaking out and corroding the metal.

A cold bonding repair system was specified to effectively seal the leak. The repair system consisted in Belzona 1511 (Super HT-Metal), Belzona 4341 (Magma CR4), Belzona 1593 and a metal plate.

First, the surface of the corroded area and the inside of the metal plate were prepared to bare metal using a grinder. Both surfaces were then cleaned and degreased. The plate was bonded using Belzona 1511 (Super HT-Metal) around the perimeter of the plate. Once in place, Belzona 4341 (Magma CR4) was injected to fill the rest of gap between the tank wall and the metal plate, ensuring 100% contact.
